# Manhole Inspection Summary

Manhole # S25E1\_009MH

Insp Date: **12/9/08 10:49 AM**

**Location** Address: **Waterview Ave.**

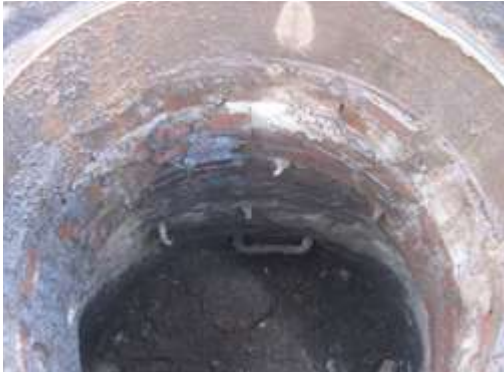
Defect 5

Condition: ☐ Sound ☐ Cracked ☐ Root Intrusion ☐ Loose Brick ☒ **Deteriorated**

Count: **3** Missing: **2** ☒ **Corroded**

missing/corroded steps, chimney deteriorated

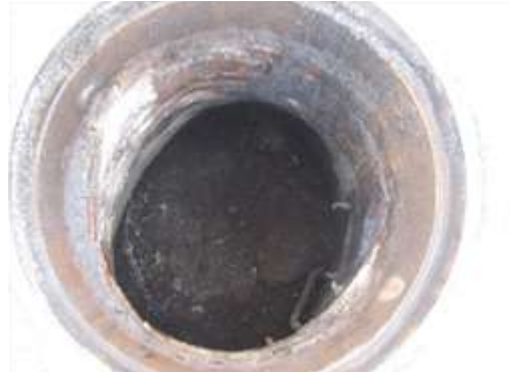
Defect 4

Offset: **2** (in.)

frame offset

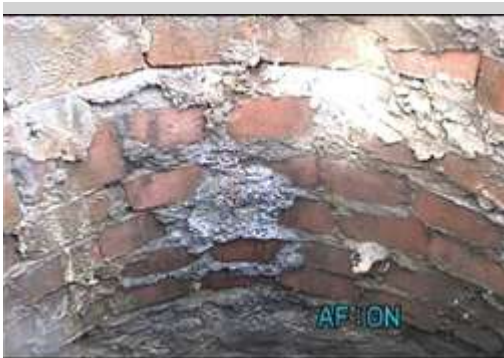
Defect 1

Condition: ☐ Sound ☒ **Cracked** ☐ Root Intrusion ☒ **Loose Brick** ☒ **Deteriorated**

Infiltration: ☐ None ☐ Joint ☐ Cracks ☒ **Mortar** ☐ Roots ☐ Wall

corbel has loose brick & is deteriorated with signs of infiltration from mortar

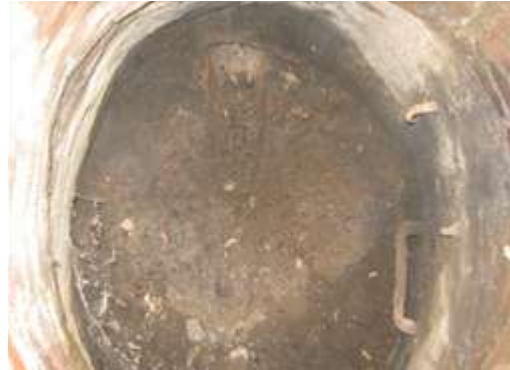
Defect 6

Condition: ☐ Sound ☐ Cracked ☐ Root Intrusion ☐ Deteriorated ☐ Leaks ☒ **Debris**

Channel Debris

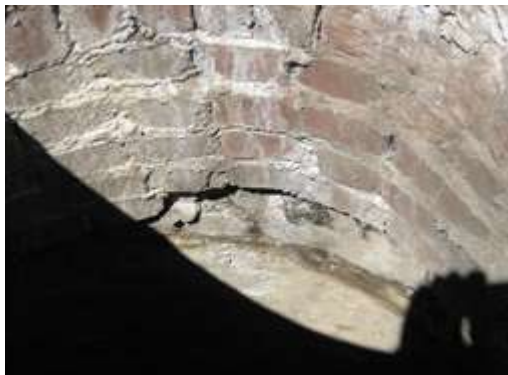
Defect 3

cracked brick in corbel

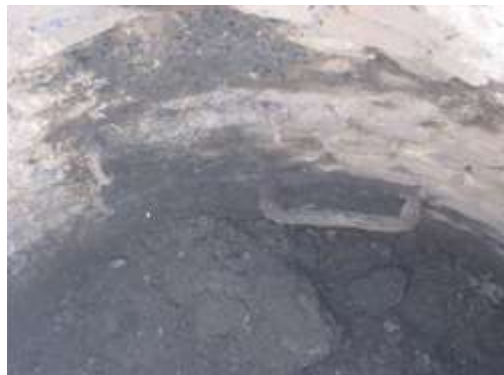
Defect 2

Infiltration: ☐ None ☐ Joint ☐ Cracks ☐ Mortar ☐ Roots ☒ **Wall**

barrel wall infiltration

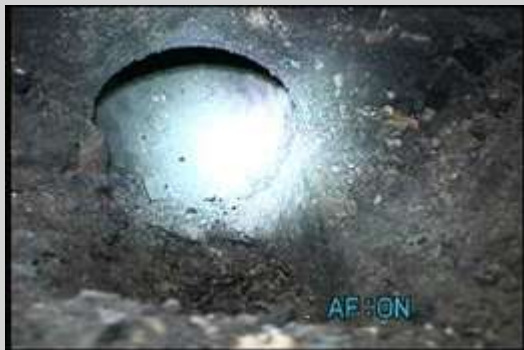
12 O'Clock Outflow

8 in. Circular Gravity Sewer  
Pipe Out @ 12 O'Clock

Infiltration: **None** Pipe Seal Cond: **Sound**
